**CAT 360**  
Catastrophe Risk from Every Perspective

## Fourth Quarter 2010

## Haiti and Chile: Polar Opposites

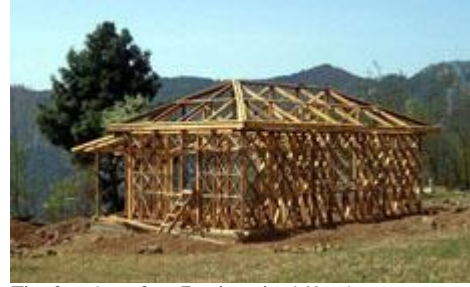
*The framing of an Earthquake / Hurricane Resistant Wood Frame Home*

While it is unlikely that the economic conditions in Haiti will significantly improve in the foreseeable future, there are techniques in developing structures that are resistant to both earthquakes and hurricanes, yet remain economically viable. These include modern wood frame structures, geodesic domes, earth sack construction and recycled steel shipping containers. Additionally, expertise in building using one of these techniques can be transferred locally, so that Haitian communities can become self-sufficient in their construction activities in the near future.

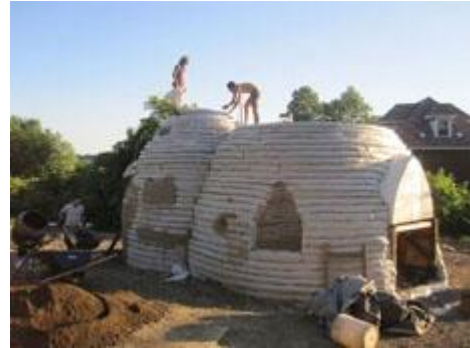
*Earth Sack Construction - Earthquake and Hurricane Resistant Housing*

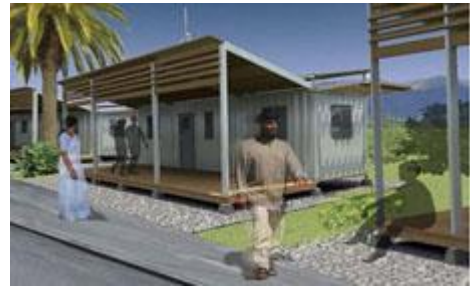
*An Artist Rendition of Shipping Container Homes*

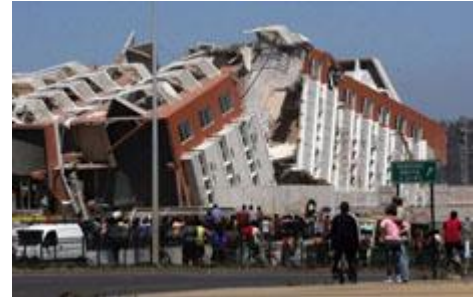
While the vast majority of buildings in Chile performed very well during the Maule event, there were catastrophic failures. One example was the Alto Río, a 15-story apartment building in Concepción. This building failed in the event, collapsing on its side and resulted in eight casualties. The failure was attributed to a flaw in the foundation design, possibly due to unanticipated liquefaction. However, even though the building did fall over, the structure did not collapse and maintained its overall shape, indicating that the structural strength was very good. The building has since been demolished.

*The Alto Río Apartment Failure*
